# *Earles Engineering & Inspection, Inc*

Attn: Mayor & Council  
EEI File 21-221

RE: Main Street Building Collapse Report

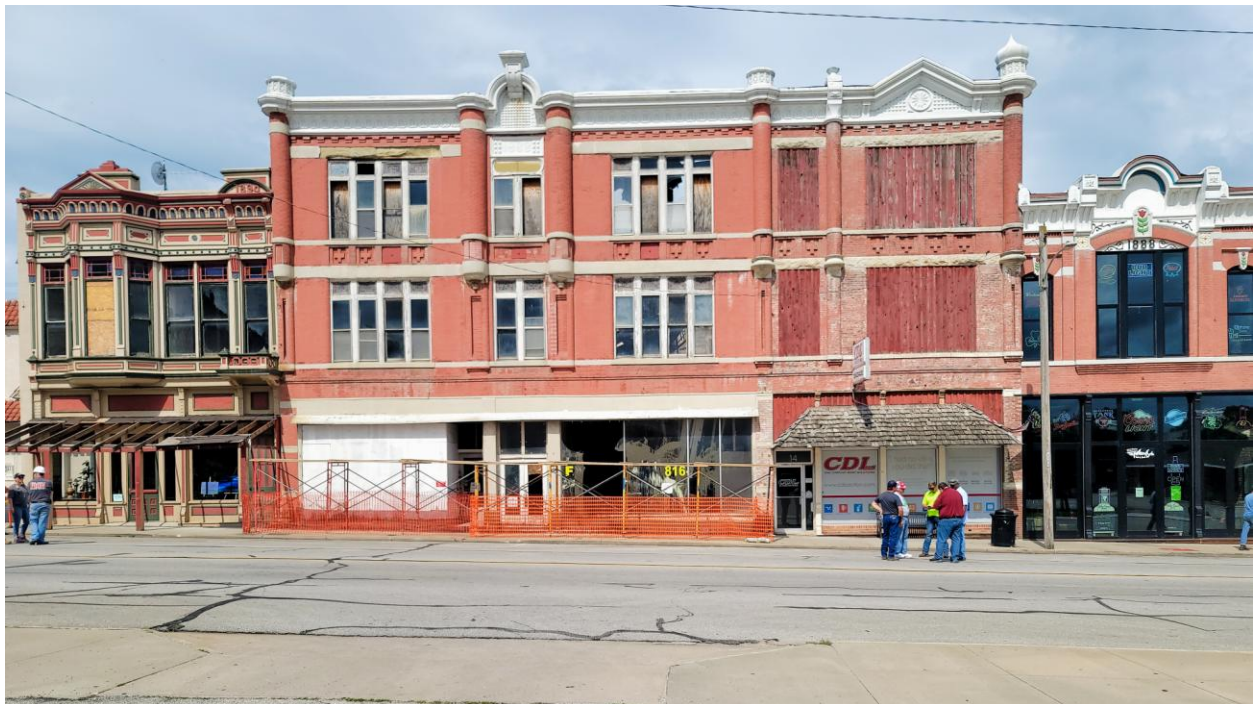
There are 4 separate yet combined buildings. It appears that all the walls are party or shared walls. The roof and partial wall collapse happened on the 3 story middle building. This roof collapse caused both sidewalls to move and partially collapse. Additionally it caused the front of the structure to move creating a bowed front of the building and numerous cracks in the bricks. Additionally I was informed that what

appears as white stone in the picture above was covering for previous wire strands stretched through the building and anchored in the front and rear walls to stabilize the building. These are now broken or under the piles of debris, causing additional destabilization of the structure.

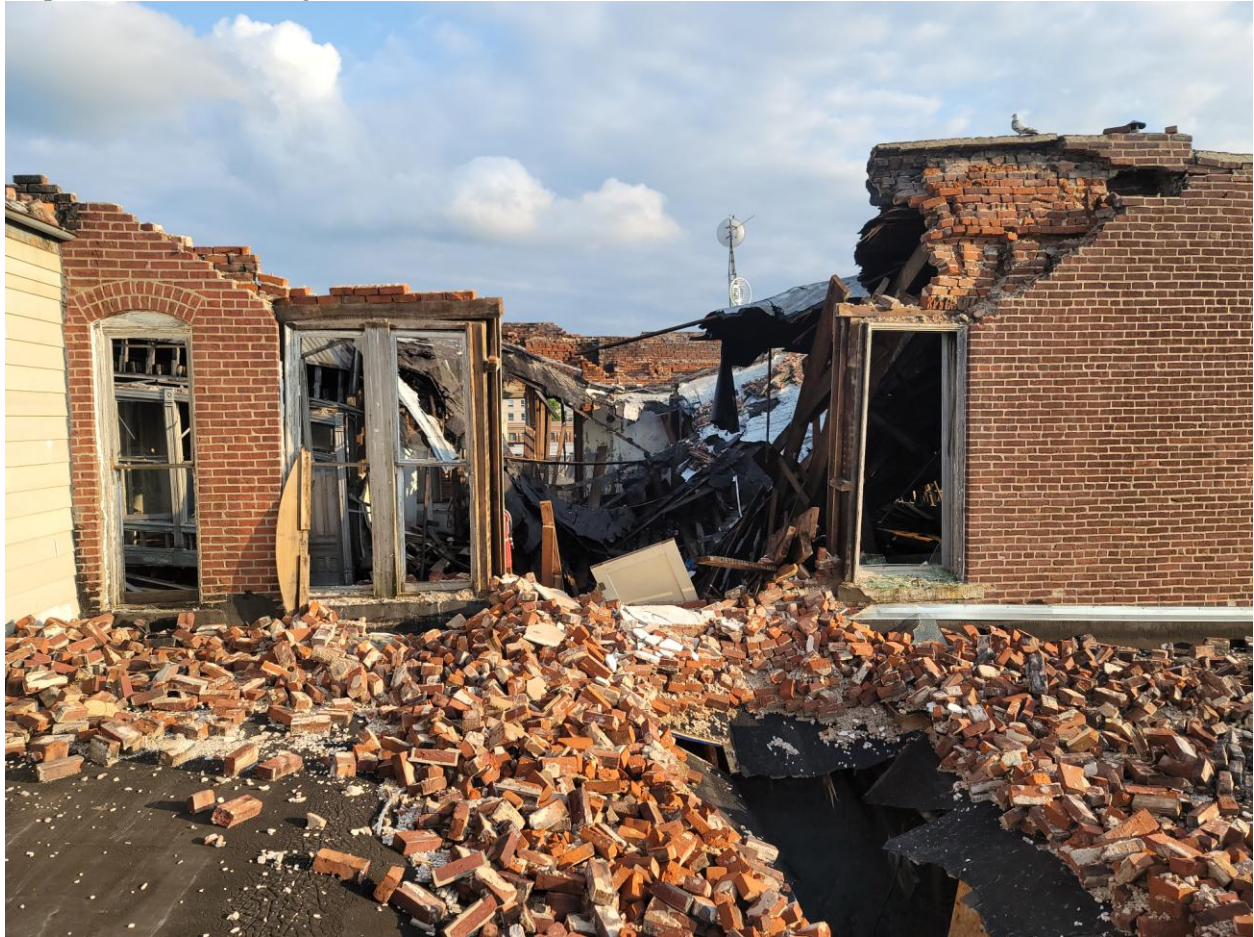
The north wall partially collapsed onto and through the roof of the CDL building to the north collapsing its roof. The next north building is a bar. It suffered no damage. We were able to get onto the bar roof and look south over the CDL building and the collapsed structure further south.

The portion of the roof of the 3 story structure is unstable and could finish the collapse at any time. The upper story from the bottom of the top windows to the roof is all leaning in and could collapse at any time. The building appears to be a total loss as well as the CDL building.

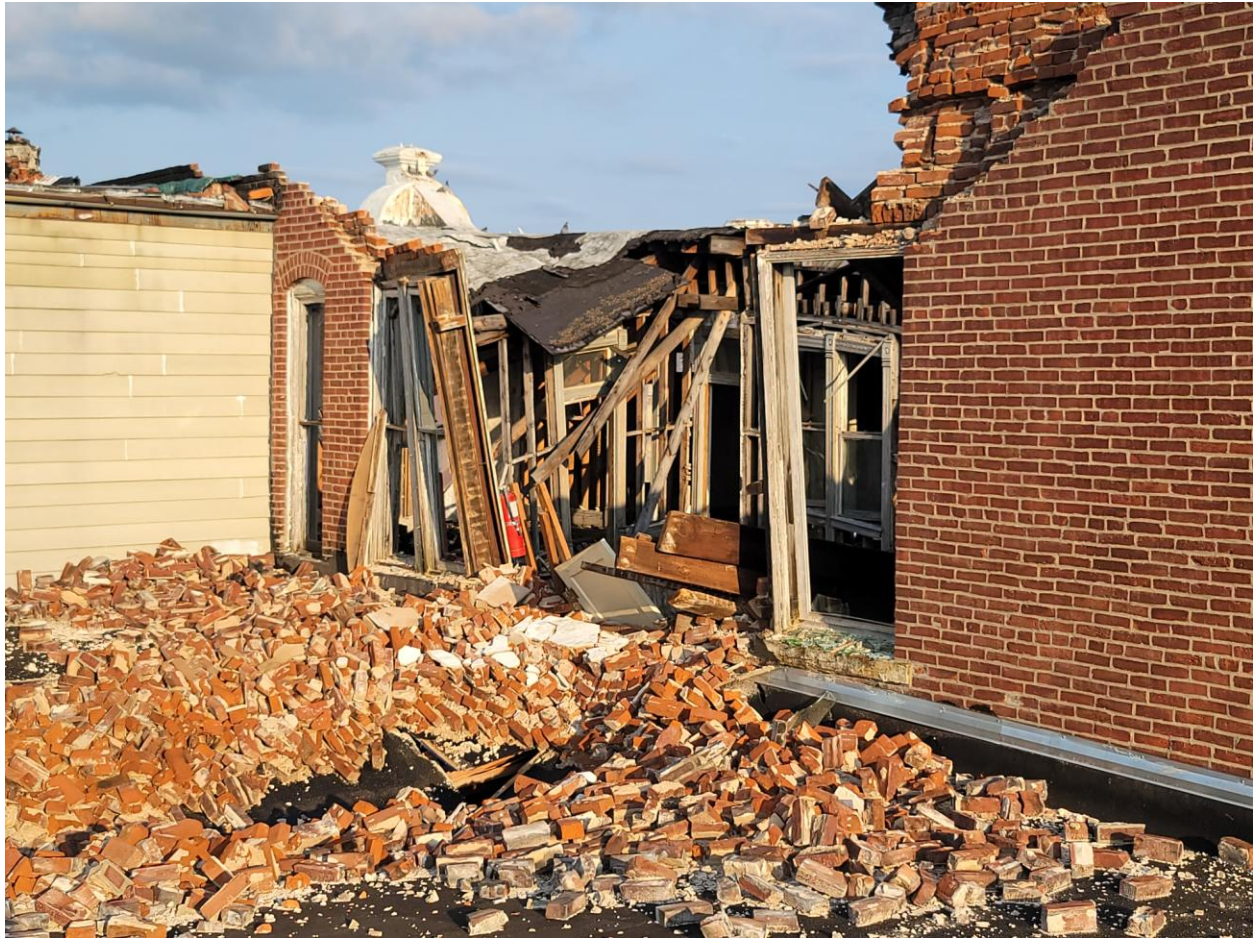
On Saturday July 17, 2021, I and City staff meet with Carl Britz with American Wrecking Services, LLC and went through the structures with him. We were able to go into the basement of the CDL building and the bar. The CDL basement showed stone and brick that had lost most of its mortar and was in very poor condition both north and south walls. The bar basement showed the mortar had mostly all been repaired and the wall looked in good condition.

After review, it was concluded that the bar could be saved by supporting its south wall and removing the upper parapet. The CDL building would need to be removed. The saved wall would need to be repaired, tuck pointed, sealed and a cap put over it as part of the reworked roof of the bar.

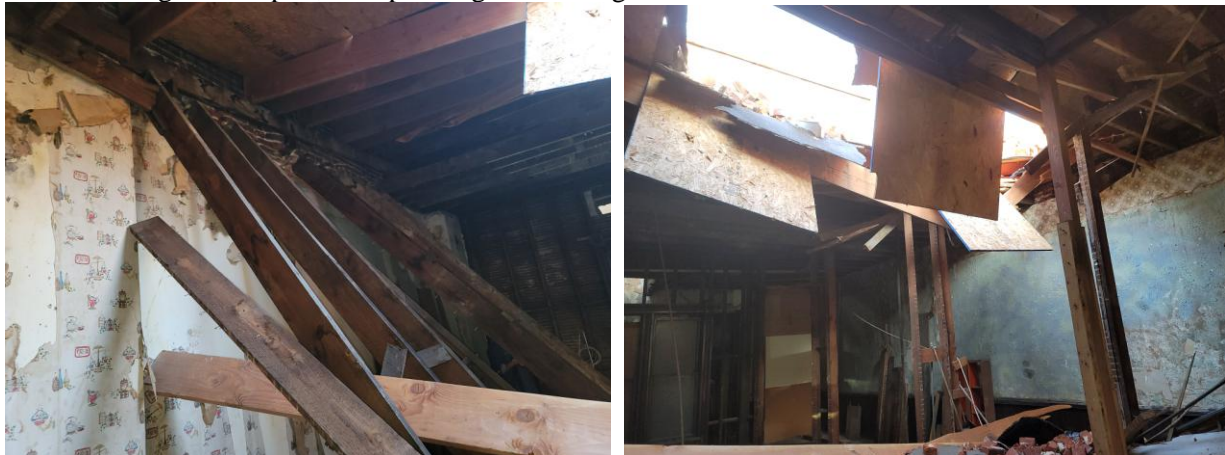
Looking at the inside of the CDL building

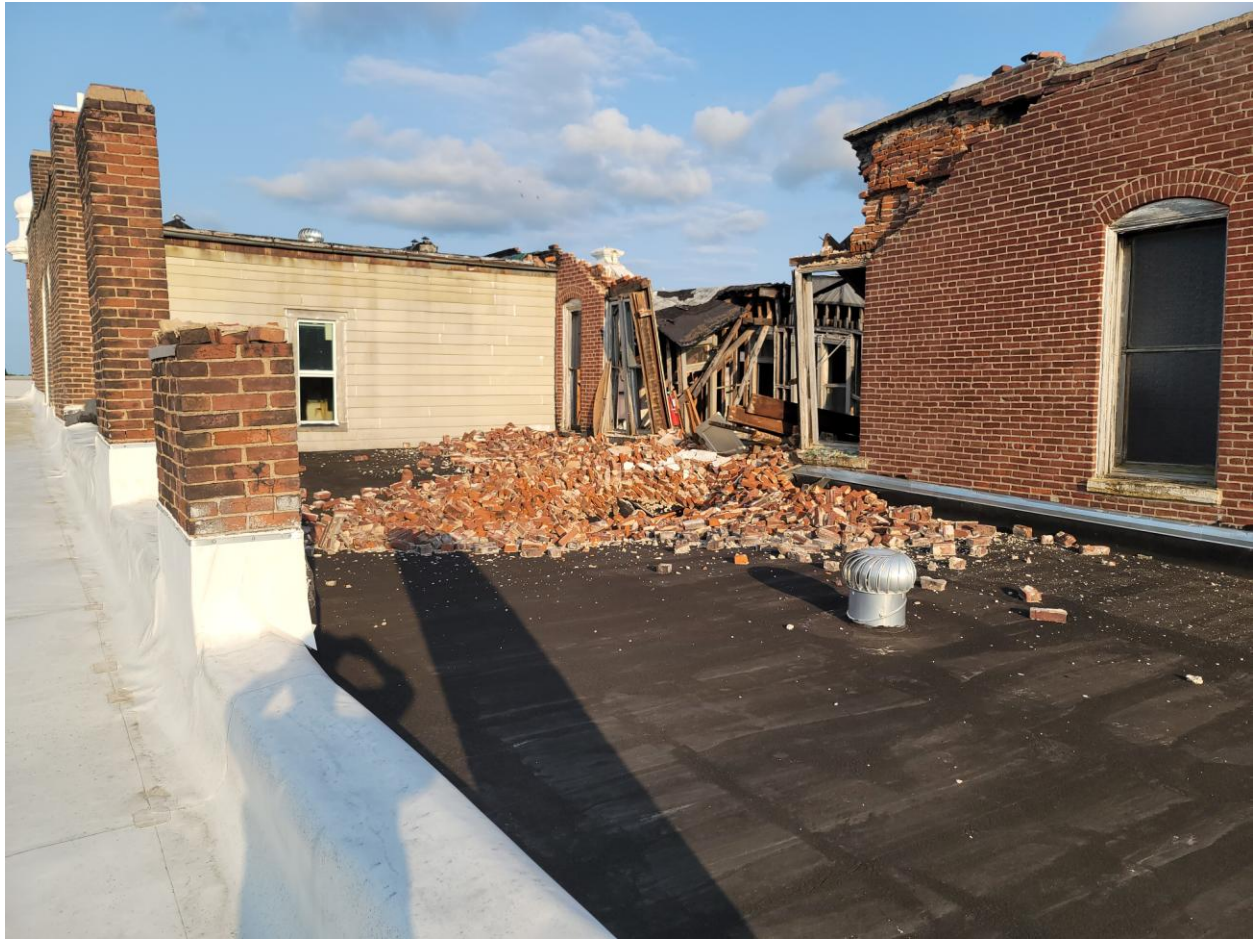
Looking east on the roof of the bar looking toward the CDL building
